Docket No. 217 – Development and Management Plan Inspection

Northeast Utilities Service Company Certificate of Environmental Compatibility and Public Need for the construction of a 345-kV electric transmission line and reconstruction of an existing 115-kV electric transmission line between Connecticut Light and Power Company's Plumtree Substation in Bethel, through the towns of Redding, Weston, and Wilton, and to the Norwalk Substation in Norwalk, Connecticut.

Norwalk Substation

Date: September 13, 2006

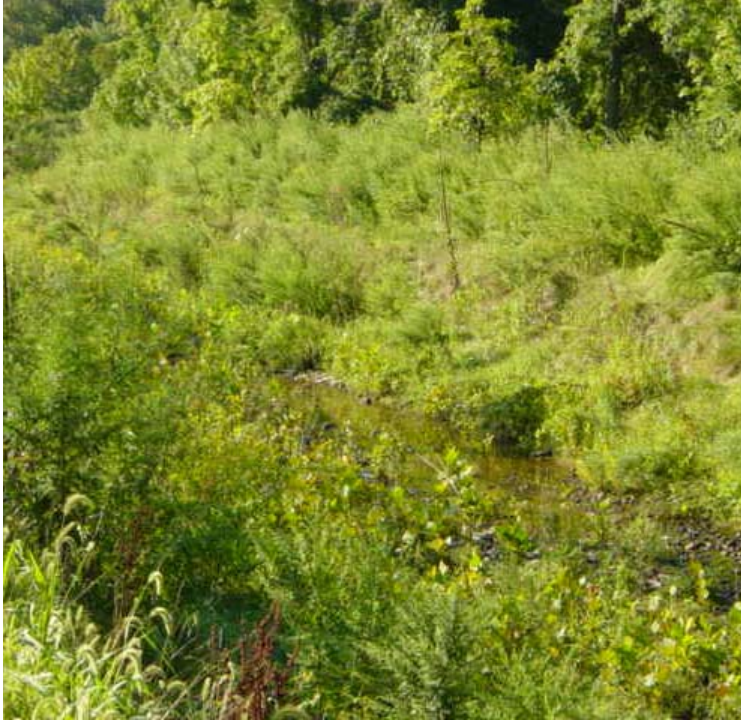
(Norwalk Substation): Photo on the left shows a view of the overflow channel, very well vegetated. (Plumtree Substation): Photo on the right shows where larger stockpiles and materials have been cleaned up. 9/13/06

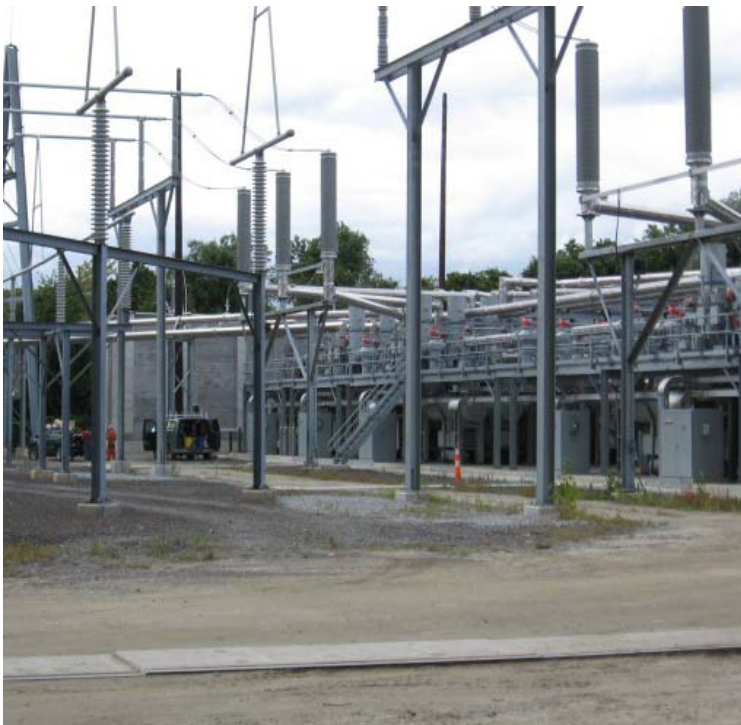
(Plumtree Substation): Photo on the left shows a current view of the yard with the equipment installed at the north (in background) of the site. Photo on the right shows remaining material storage in the yard and the general clean up. 9/13/06
